Effects of Late Holocene Debris Flows on Lava Falls Rapid, Grand Canyon National Park, Arizona

U.S. GEOLOGICAL SURVEY
Open-File Report 96—460

By ROBERT H. WEBB, THEODORE S. MELIS, THOMAS W. WISE, and JOHN G. ELLIOTT

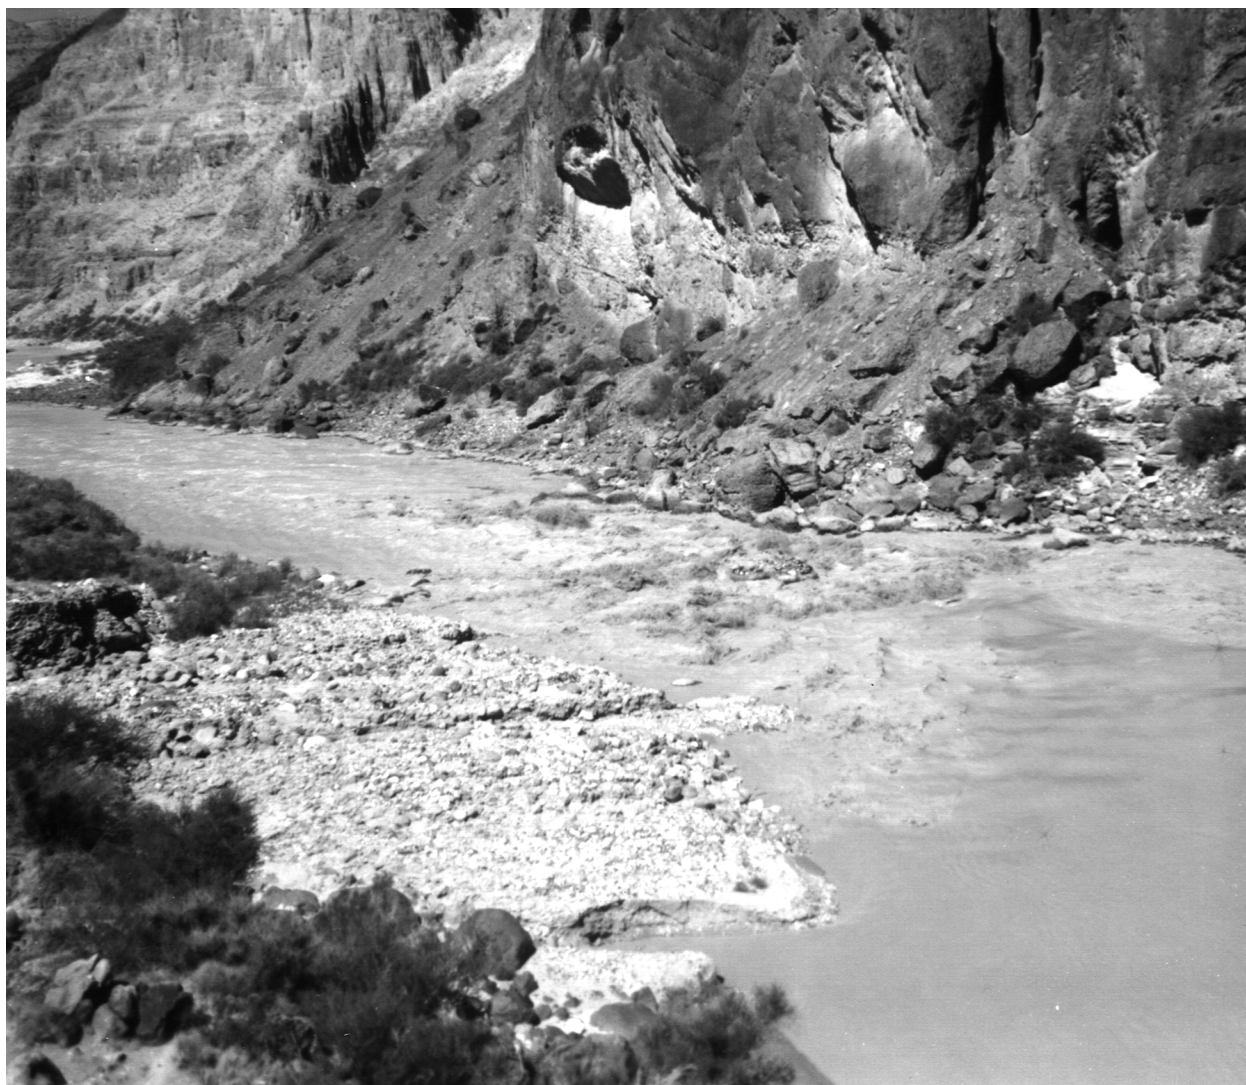
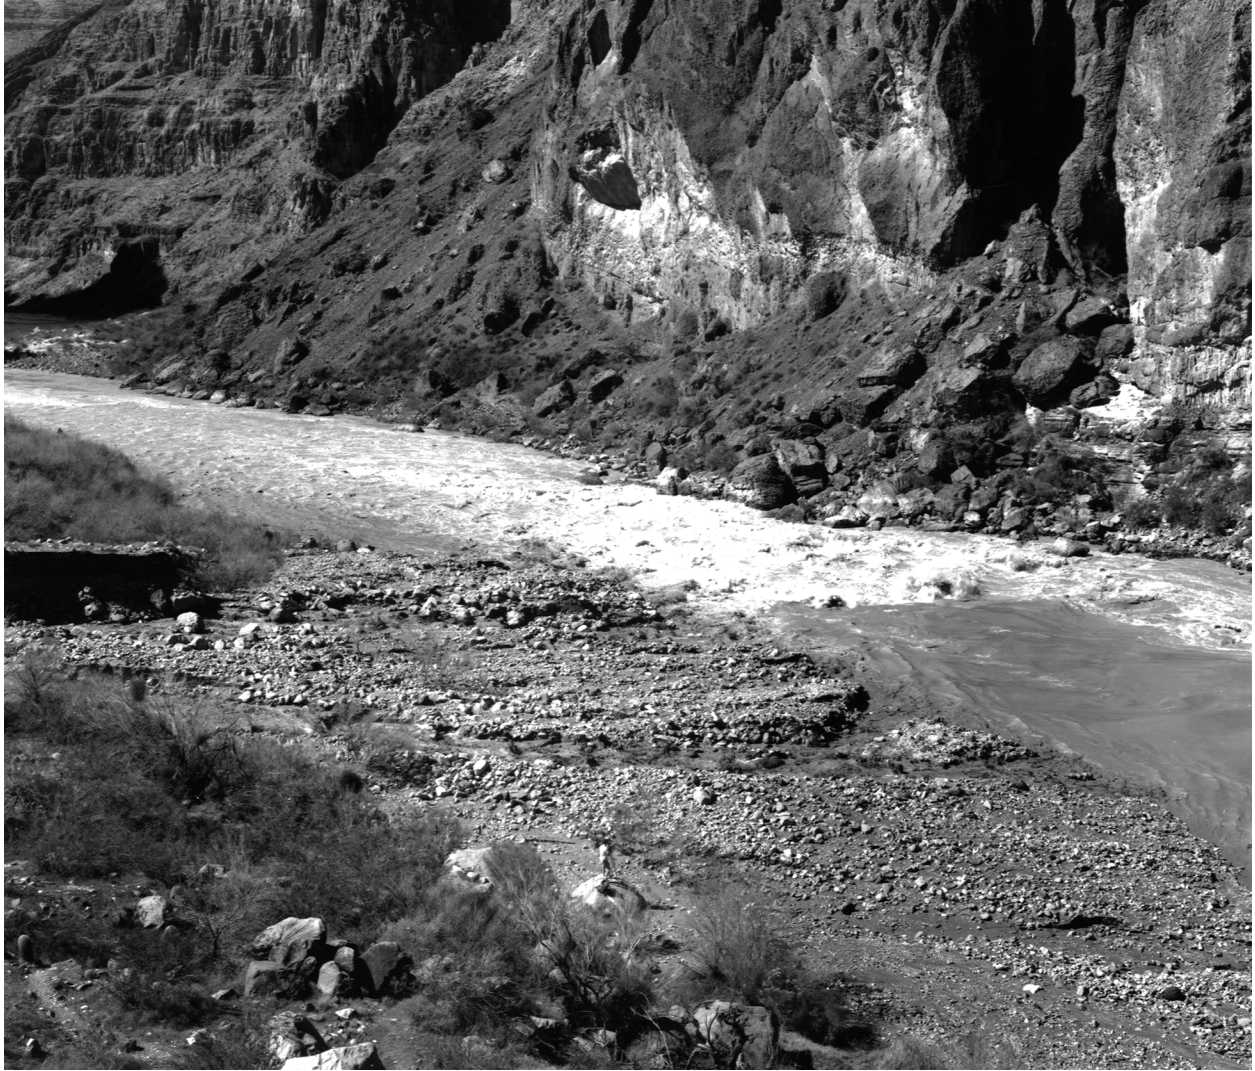
Figure 26. Downstream view of Lava Falls Rapid from the high surface on the left side (Stake 2964b). A. (August 1967; G. Luepke). At a discharge of about $340 \text{ m}^3/\text{s}$, the 1966 debris flow constricts the Colorado River by about 36 percent. According to the first river runner to view the rapid, the only effect of this debris flow was to eliminate the Left Run. A typical dam release and a small flood in the Little Colorado River on April 19, 1973, combined to form a peak discharge of $1,080 \text{ m}^3/\text{s}$, which removed the 1966 deposit.

B. (March 6, 1995; R.H. Webb). The deposit of the March 1995 debris flow was much larger than that of the 1966 event, but the shape is remarkably similar. The amount of sediment deposited in 1995 is about half the amount deposited during the 1955 debris flow.

Canyon (mile 65.5; Cooley and others, 1977; Webb and others, 1989) and elsewhere along the river, is the likely cause for the debris flow. An August 1967 photograph (fig. 26a) shows the extent of the aggraded debris fan. In addition to the poorly-sorted debris fan, small boulders were deposited on the left side of Lava Falls Rapid, reportedly closing off a previously used run (John Cross II, written commun., 1967). Most of the 1966 debris fan was removed by relatively small dam releases in 1972 and a small flood in the Little Colorado River in 1973.

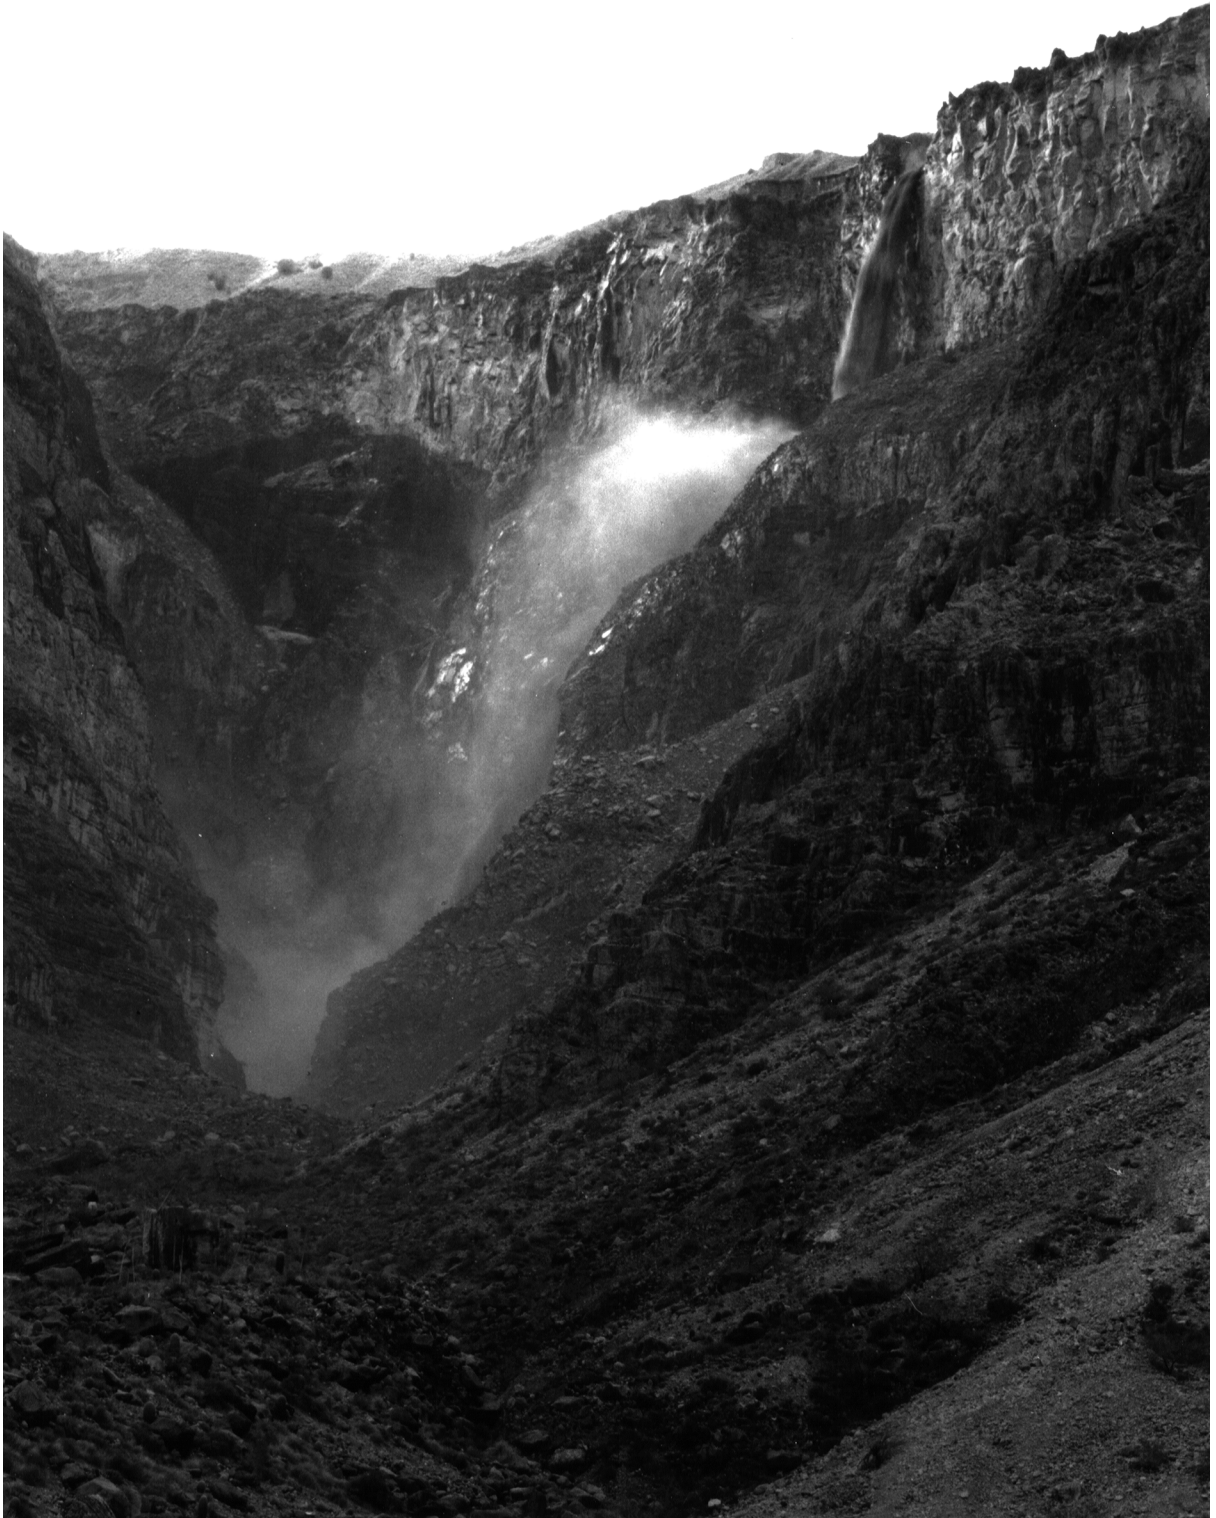
Figure 27. (March 6, 1995; S. Tharnstrom). The firehose effect created by streamflow falling over a 325-m fall at the head of Prospect Canyon on March 6, 1995

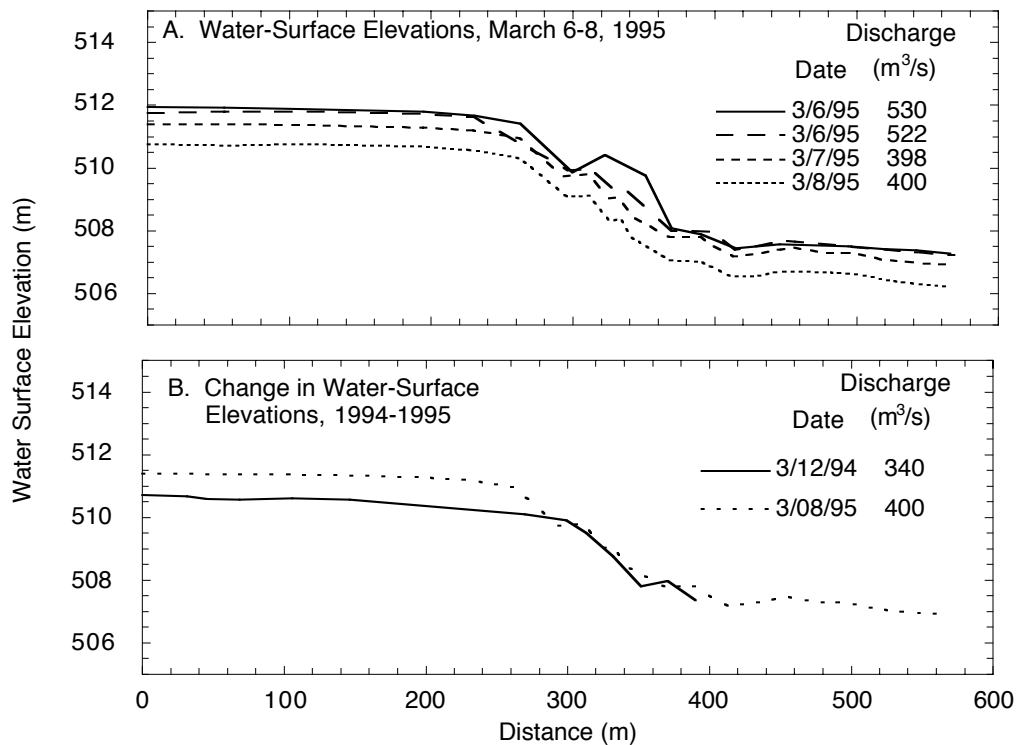
Figure 29. Longitudinal profile of the water-surface fall on the right side of Lava Falls Rapid. A. March 6-8, 1995. B. Comparison of water-surface profiles in March 1994 and March 1995.

Flow in the river was confined to a channel about 50 percent of its previous width, which caused distinct changes to the hydraulics of Lava Falls Rapid. The water-surface profile (fig. 29a) initially was greatly influenced by large waves on

The rapid changed slowly after noon on March 6. By mid-afternoon, a run developed just to the left of the Ledge Hole. By March 8, the configuration of the rapid and its water-surface profile stabilized (fig. 29). At a discharge of 400 m³/s, the constriction from the new debris fan caused the stage in the rapid to appear as if the discharge was 170 m³/s higher. The drop at the head of the rapid increased by 0.9 m from the 1994 water-surface profile for a roughly equivalent discharge (fig. 29b), although the stage remained similar through the rapid; in other words, the total drop through the main part of the rapid increased from 3.1 m in 1994 to 4.0 m in 1995.

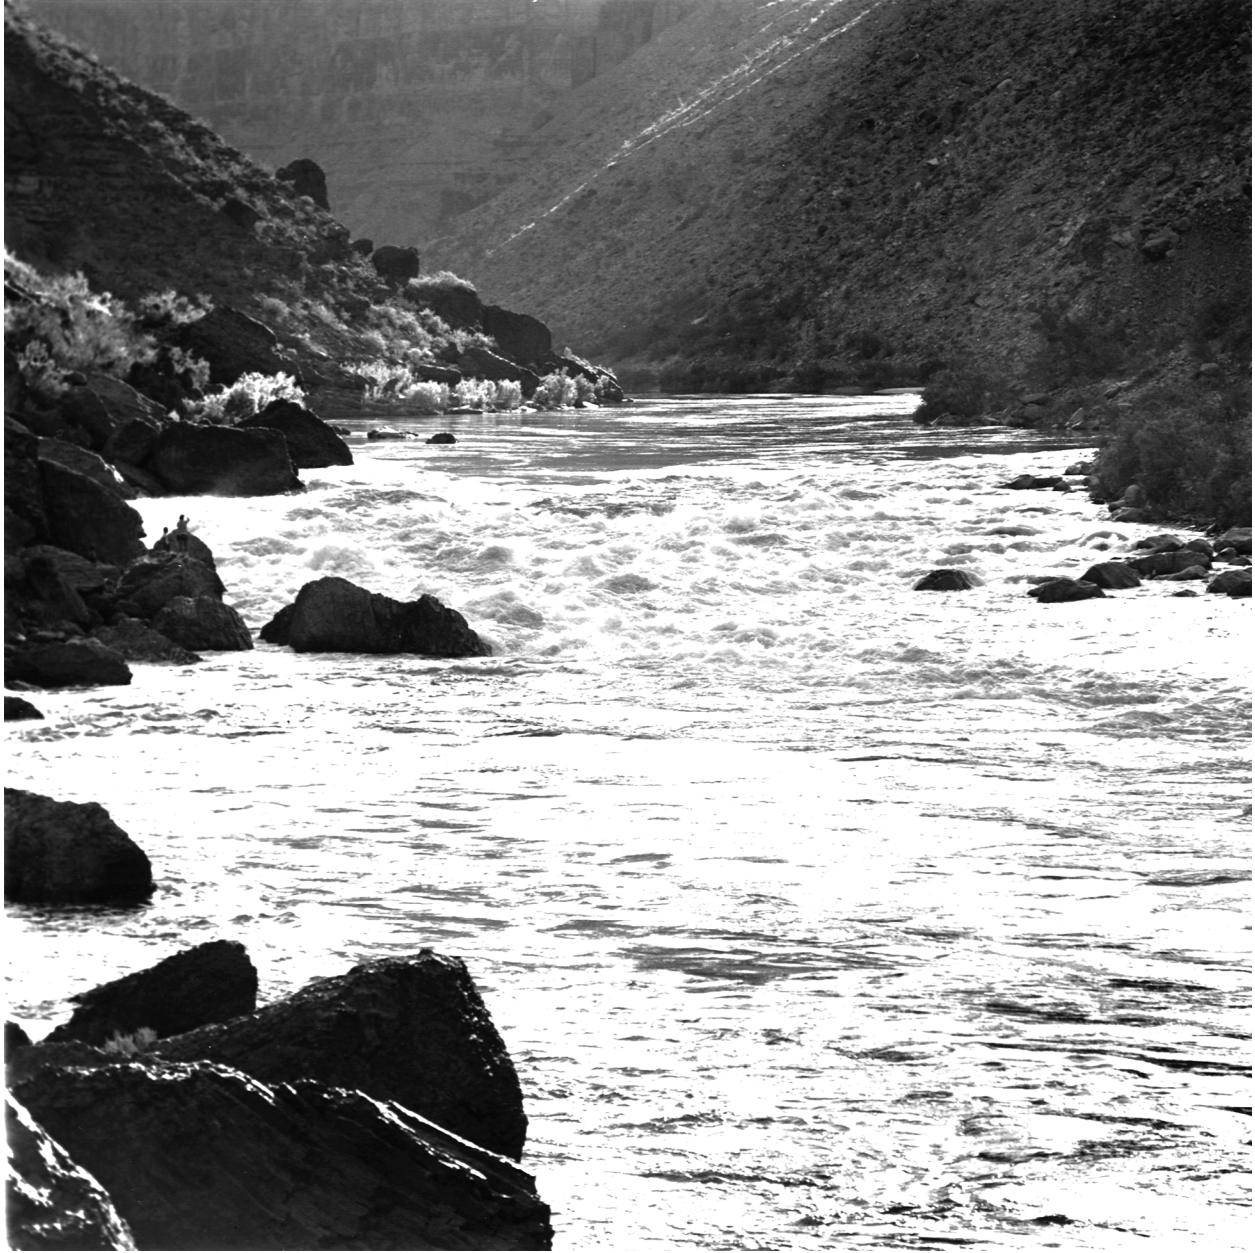
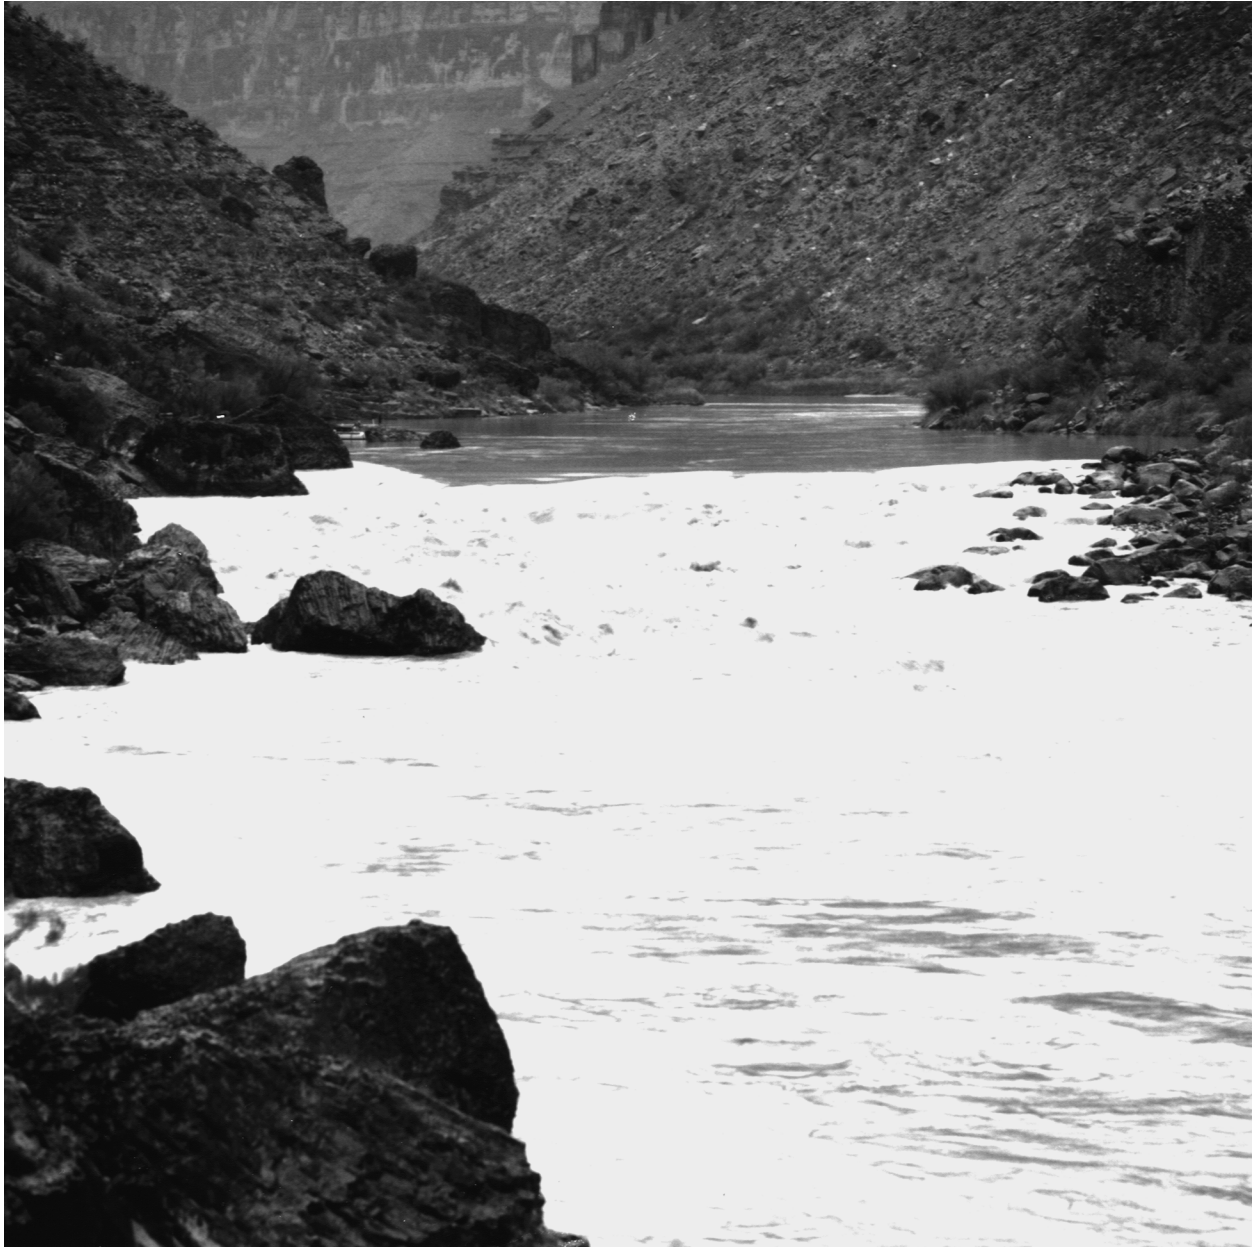
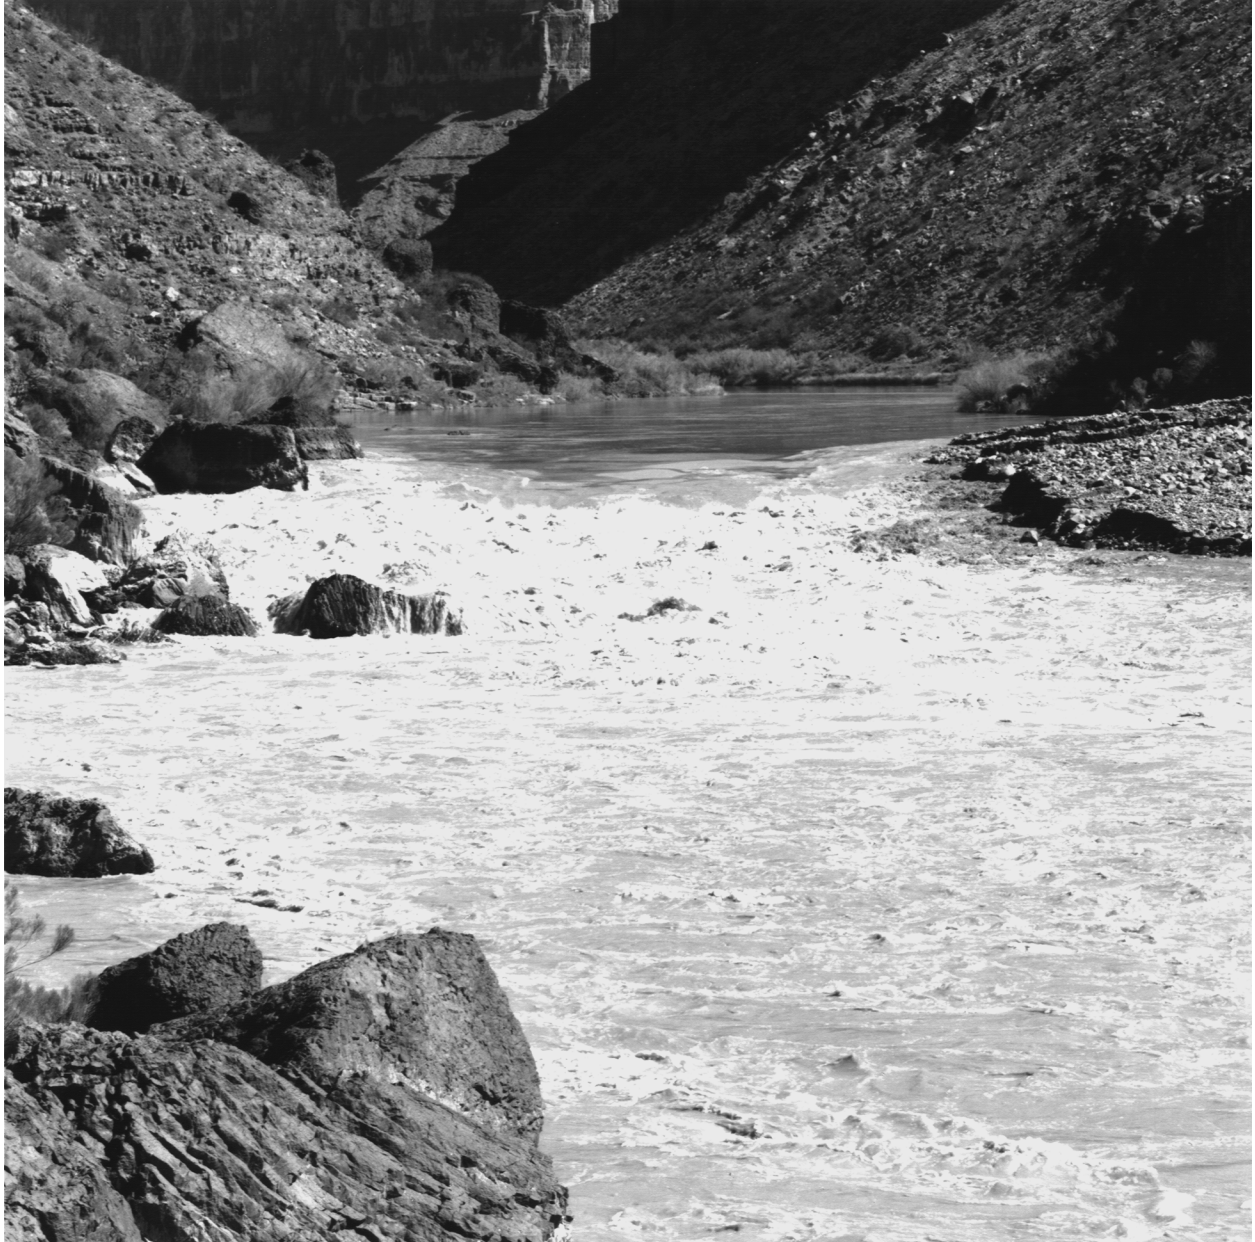
Figure 30. Upstream view of Lava Falls Rapid from the lower right (Stake 2962). A. (1973; M. Litton). At a discharge of about $370 \text{ m}^3/\text{s}$, Lava Falls appears to be continuous, frothy whitewater. For safety purposes, river runners commonly floated in the foreground eddy until all boats were through the rapid. Dense riparian vegetation grew next to river level on the debris fan at right. The Black Rock is prominent at left center.

B. (March 5, 1995; S. Tharnstrom). More rocks were exposed on the debris fan in this view, which shows about 310 m^3/s in the rapid. There is no change between 1972 and 1995 except that riparian vegetation was scoured away during Colorado River floods in 1983 and 1993.

C. (March 6, 1995; S. Tharnstrom). The 1995 debris flow occurred about 11 hrs before this photograph was taken. A small flood of $500 \text{ m}^3/\text{s}$ in the Colorado River, combined with $14\text{-}28 \text{ m}^3/\text{s}$ of recessional flow in Prospect Canyon, reworked the distal edge of the debris fan. Water pours over the Black Rock, where it previously had not until discharges greater than $700 \text{ m}^3/\text{s}$. Fast water replaced the eddy in the foreground because reworked cobbles and gravel filled the pool downstream from the rapid.

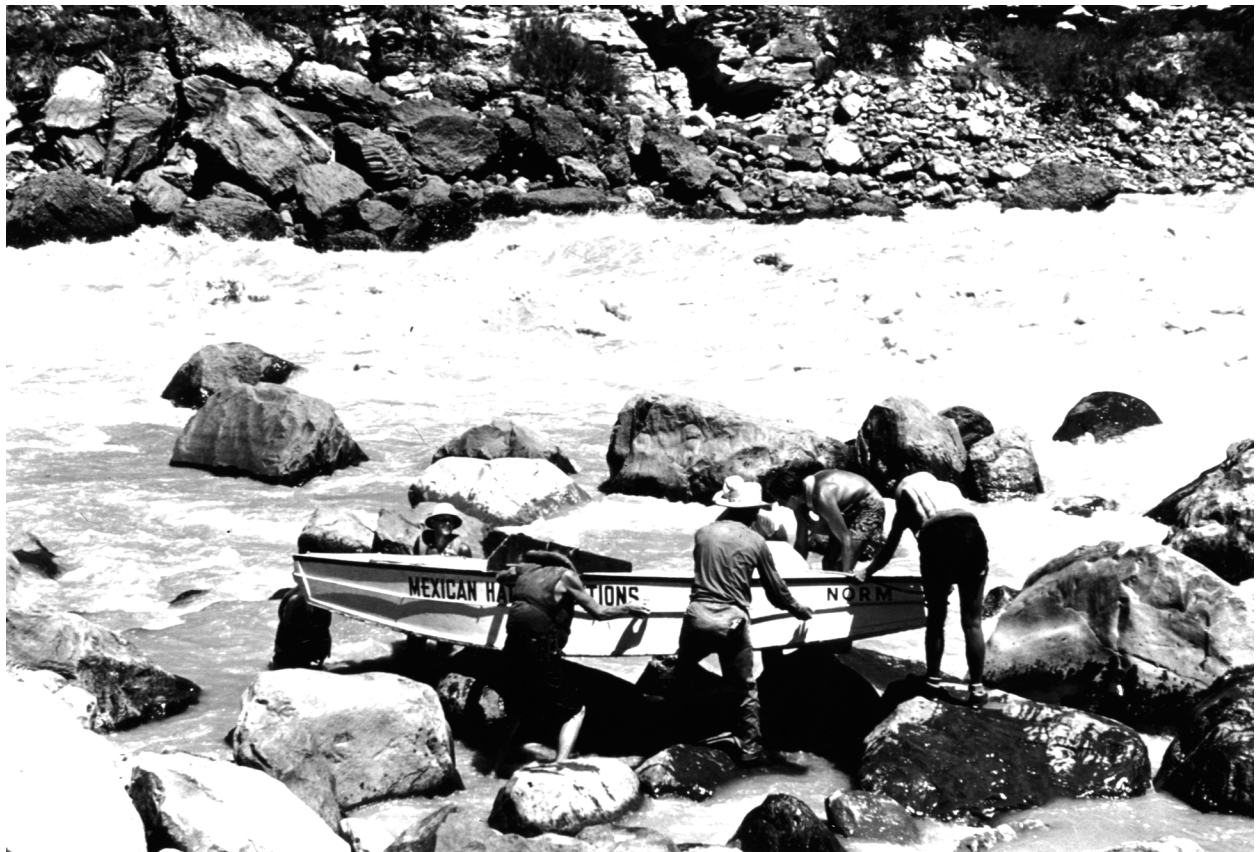
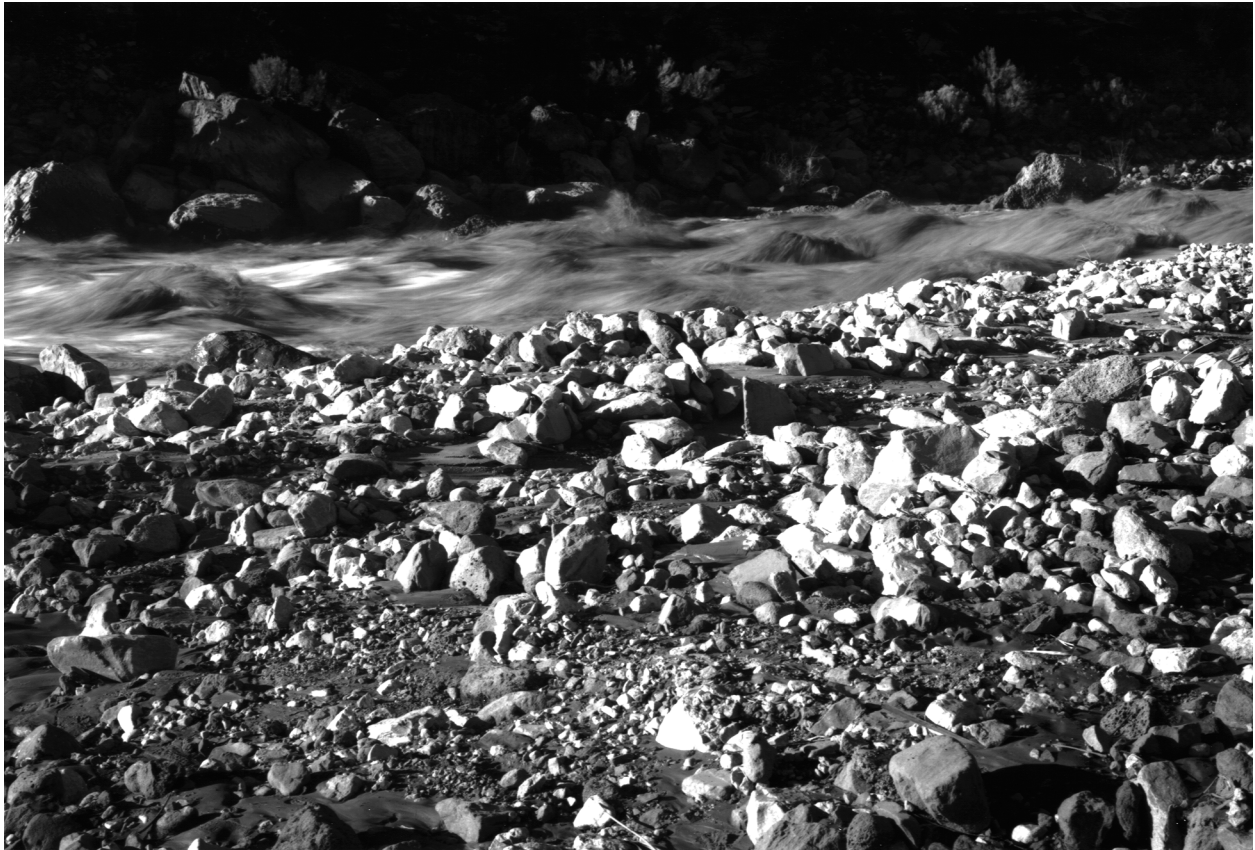
Figure 31. View across Lava Falls Rapid from river left (Stake 2969). A. (July 1952; T. Nichols). Before the advent of rubber rafts, most river trips portaged boats around Lava Falls Rapid. Here, Mexican Hat Expeditions trip paused during a portage with the boat completely out of the water on large boulders deposited in 1939.

B. (March 7, 1995; D. Oldershaw). This match, which may be off by a meter or more, shows deposition by the 1995 debris flow. This view is probably similar to the view from the aggraded debris fans in 1955 and 1963; the 1954 and 1966 debris flows were considerably smaller. One of the boulders visible in the 1952 view is present at left center.

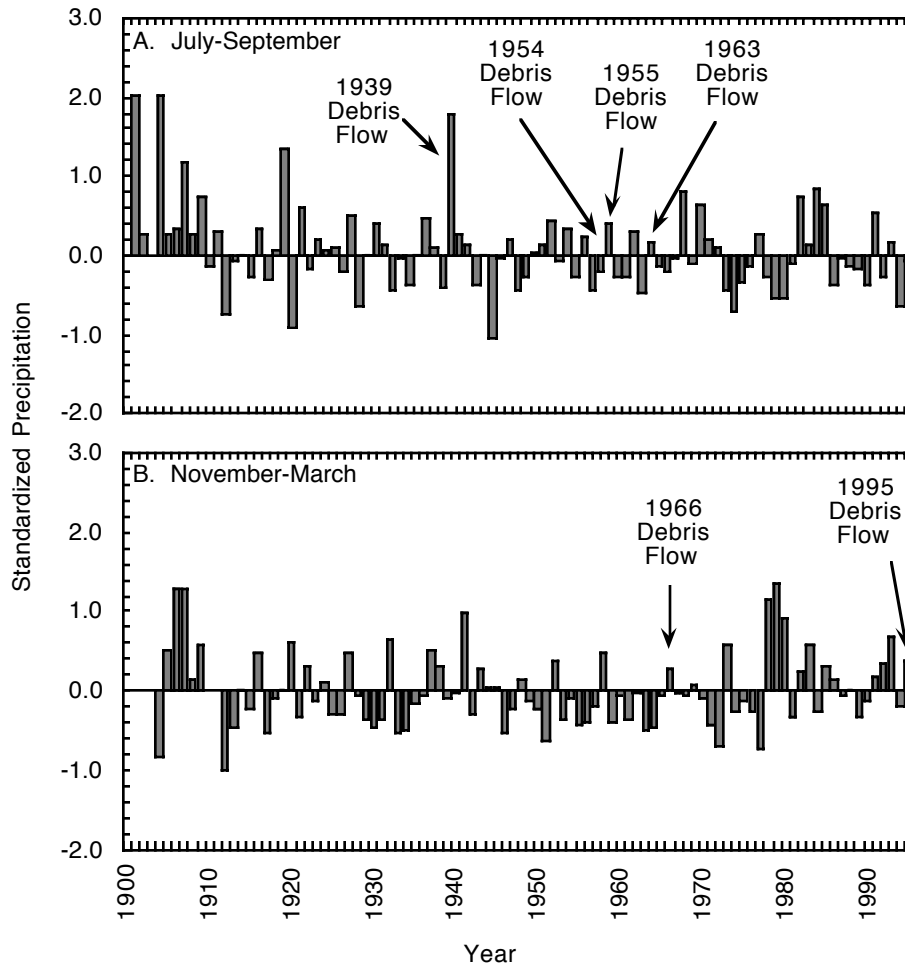
Figure 32. Standardized seasonal precipitation for eight stations in the vicinity of western Grand Canyon (appendix 2). Seasonal precipitation is converted to a time series with mean = 0 and variance = 1; positive values represent above average precipitation, whereas negative values are below-average precipitation. A. Summer (July-September) precipitation. B. Winter (November-March) precipitation.
